Attachment 3. DOE/LANL has used improper fluid-assisted drilling methods that mask detection of groundwater contamination for the installation of the LANL characterization wells that are planned to be used as monitoring wells.

As-Built Schematic for LANL Characterization Well R-16

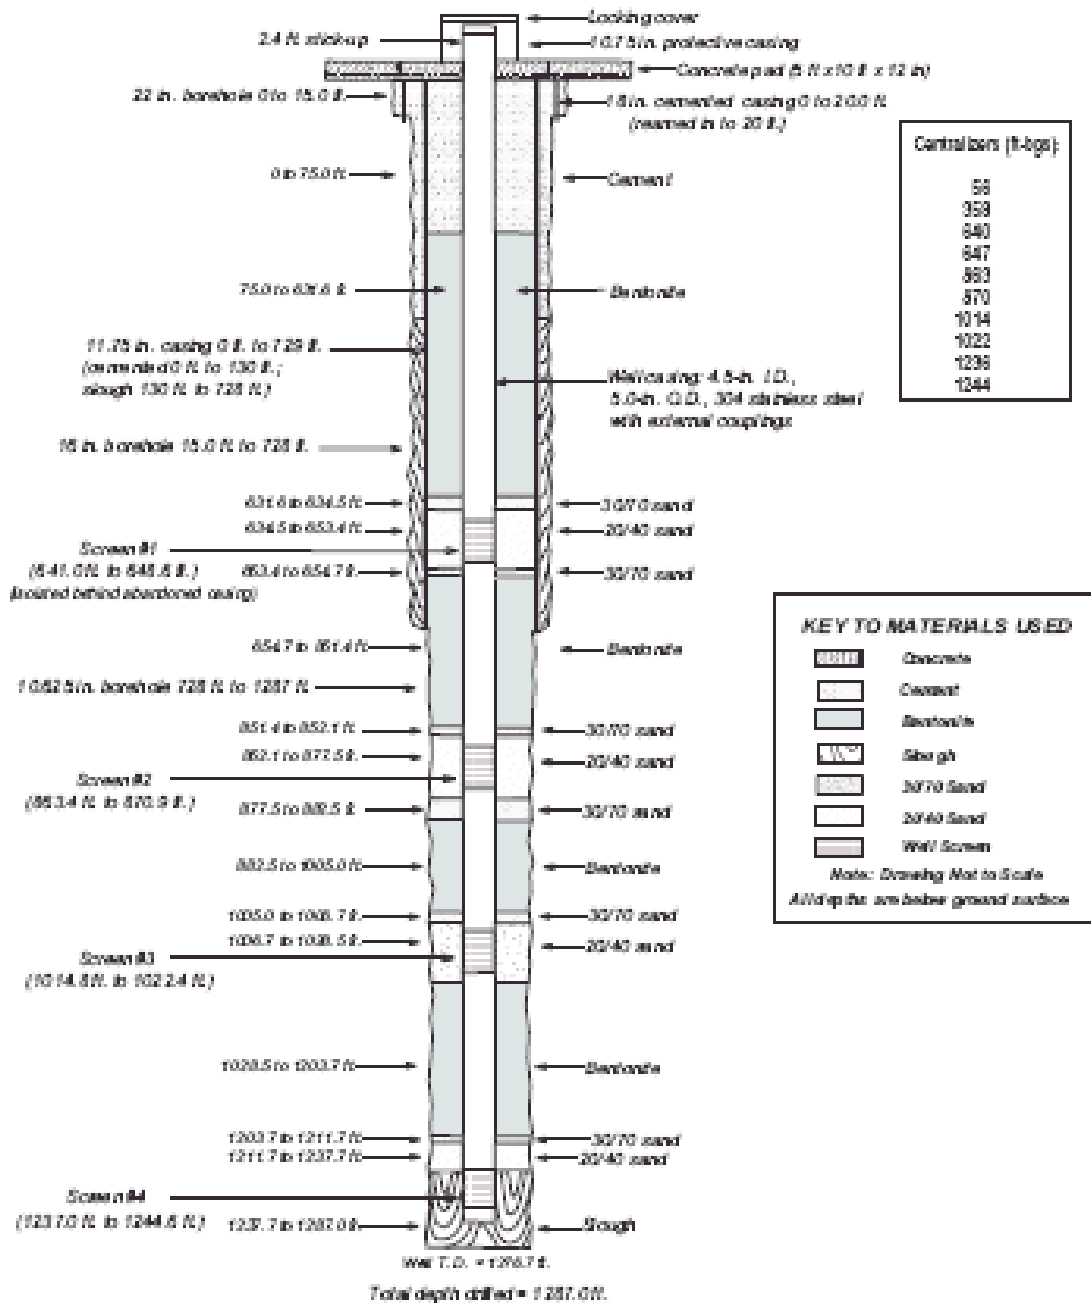
The as-built schematic for well R-16 is shown below. The retractable drill casing that was abandoned in the borehole blocks off screen #1. Screen #4 does not produce representative groundwater samples because the screen is surrounded by bentonite clay slough sediments that were not cleaned from the borehole before the well was constructed. None of the well screens produce reliable and representative water samples because of the mud-rotary drilling method that invaded the screened intervals with organic and bentonite clay drilling fluids.

However, the information in the LANL well R-16 Completion Report (LA-UR-03-1841, June 2003) is proof that the casing advance drilling method was not responsible for the abandonment of retractable drill casing in the well R-16 borehole. The borehole for well R-16 was first drilled with the open hole fluid-assisted air rotary drilling method to a depth of 729 feet below ground surface (bgs). Because of the difficult drilling with open hole methods, a decision was made to withdraw the open-hole drilling equipment and install cemented steel casing to stabilize the open borehole.

After the unstable strata collapsed into the open borehole and the casing could not be lowered into the borehole, a decision was made to use the casing advance drilling method to advance one dimension of retractable drill casing to a depth of 729 feet bgs. Because of the unstable strata, three strings of telescoped drill casing should have been used for drilling to the 729-foot depth. The three different diameters of drill casing were available for use, and the three strings would have greatly reduced the friction that resulted from drilling with one string.

An additional problem is that the Schlumberger[®] borehole geophysics report, included as an appendix in the LANL Well R-16 Completion Report, shows that the well screens are not installed in the strata with highest permeability, the aquifer strata that are the fast pathways for contaminants to travel to the Buckman Wellfield. There are many factors that require replacement of Well R-16.
